**Flood Control Project Maintenance
Levee Inspections**

2014 Channel Summary Report

Placer County

Truckee River

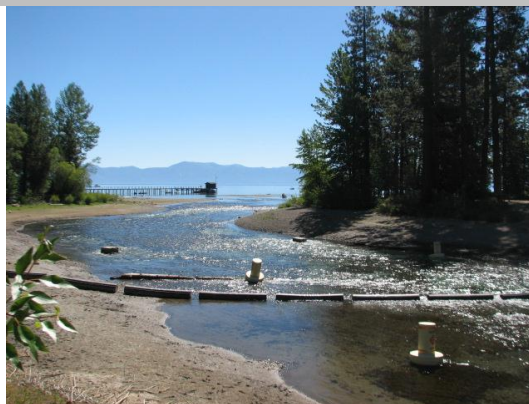
Photo 1 of 3 : CH_2014_NA0045_13_1_20140703_00013.jpg

Inspector Comments: Minimal, scattered obstructions or vegetation. The flow is not impeded.

The water is shallow coming out of Lake Tahoe. Summer 2014

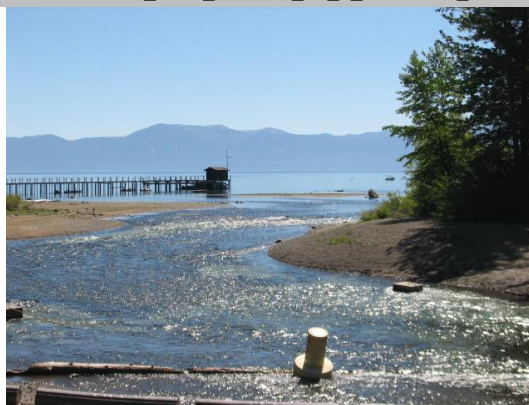
Photo 2 of 3 : CH_2014_NA0045_13_1_20140703_00012.jpg

Looking upstream at the very low flow out of Lake Tahoe. Summer 2014

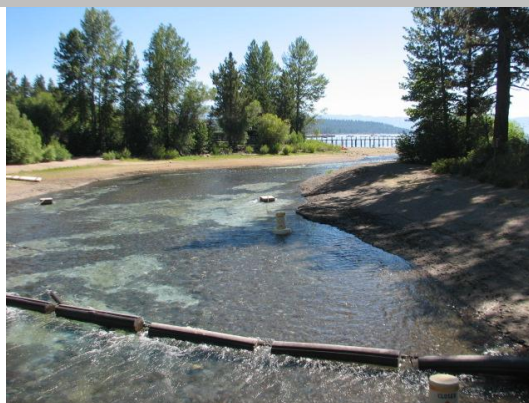
Photo 3 of 3 : CH_2014_NA0045_13_1_20140703_00011.jpg

Standing on the walkway looking upstream at Lake Tahoe. Summer 2014

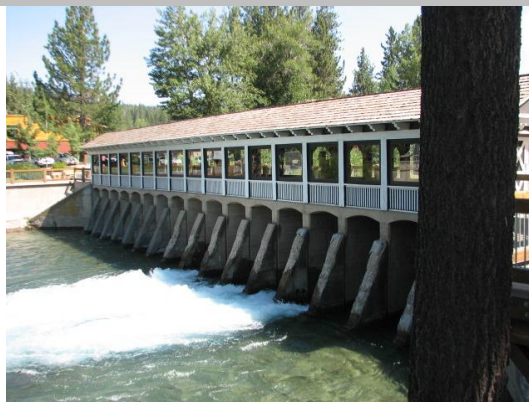
Photo 1 of 2 : CH_2014_NA0045_13_6_20140616_00002.jpg

Inspector Comments: Minimal, scattered obstructions or vegetation. The flow is not impeded.

A side view of the downstream side of the structure. Summer 2013

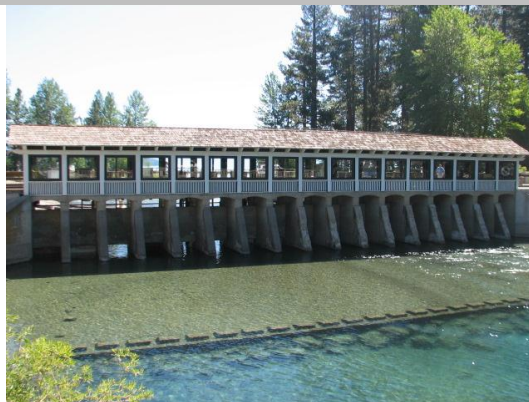
Photo 2 of 2 : CH_2014_NA0045_13_6_20140703_00014.jpg

Looking at the outlet structure from Highway 89. Summer 2014

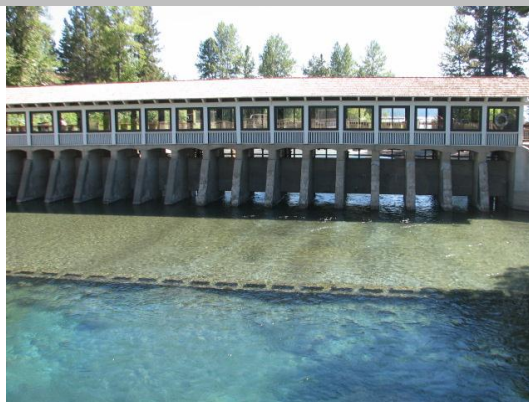
Photo 1 of 2 : CH_2014_NA0045_13_11_20140703_00015.jpg

Inspector Comments: The flow going out the control structure is very low. Minimal, scattered obstructions or vegetation. The flow is not impeded.

Looking upstream from Highway 89 at the outlet structure. Summer 2014

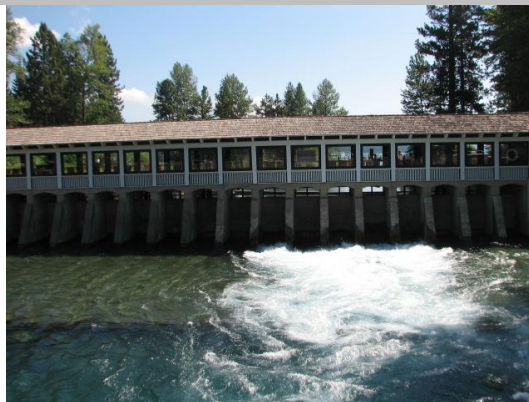
Photo 2 of 2 : CH_2014_NA0045_13_11_20140616_00003.jpg

From Highway 89 looking at the outlet structure. Summer 2013

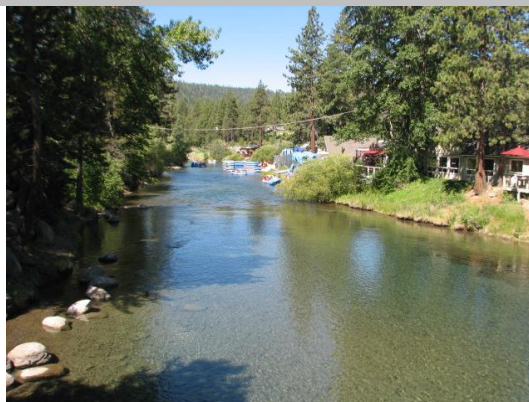
Photo 1 of 2 : CH_2014_NA0045_13_16_20140703_00016.jpg

Looking downstream from Highway 89. Summer 2014

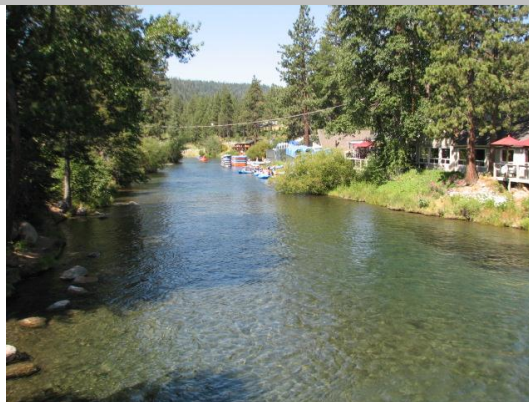
Photo 2 of 2 : CH_2014_NA0045_13_16_20140616_00004.jpg

Downstream of the Truckee River from Highway 89. Summer 2013

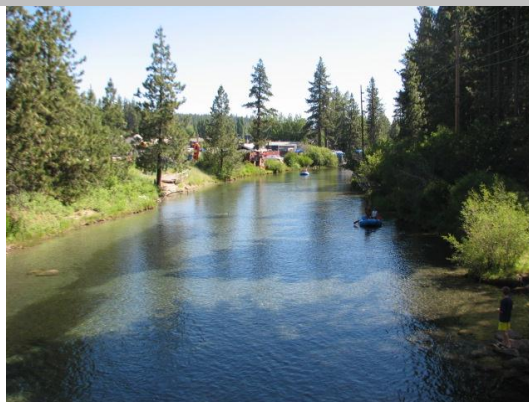
Photo 1 of 2 : CH_2014_NA0045_13_21_20140703_00017.jpg

Looking upstream from the bike bridge. Summer 2014

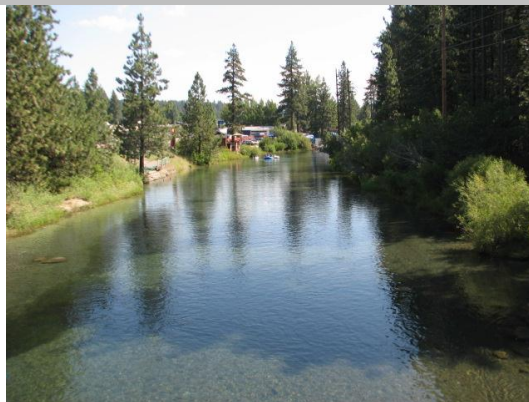
Photo 2 of 2 : CH_2014_NA0045_13_21_20140616_00005.jpg

An upstream look of the Truckee River. Summer 2013

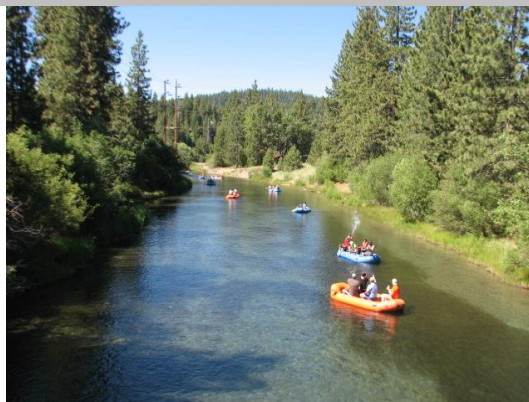
Photo 1 of 2 : CH_2014_NA0045_13_26_20140703_00018.jpg

Inspector Comments: Minimal, scattered obstructions or vegetation. The flow is not impeded.

Looking downstream from the bike bridge. Summer 2014

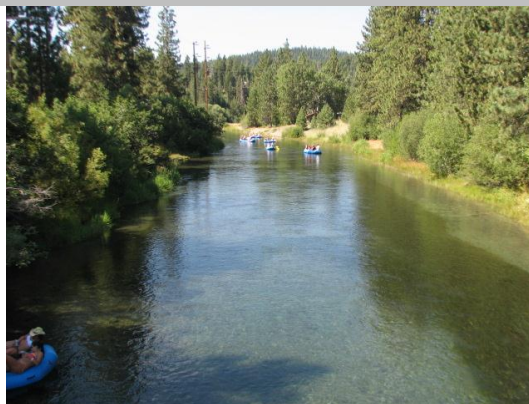
Photo 2 of 2 : CH_2014_NA0045_13_26_20140616_00006.jpg

Inspector Comments: Minimal, scattered obstructions or vegetation. The flow is not impeded.

A downstream look of the Truckee River. Rafters are having fun.
Summer 2013

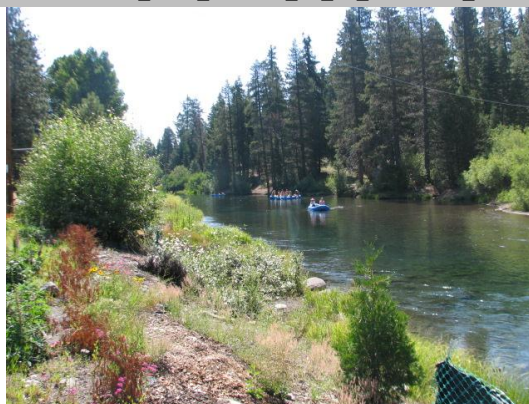
Photo 1 of 4 : CH_2014_NA0045_13_31_20140616_00007.jpg

Inspector Comments: Minimal, scattered obstructions or vegetation. The flow is not impeded.

Looking upstream from Tahoe City Lumber Yard. Summer 2013

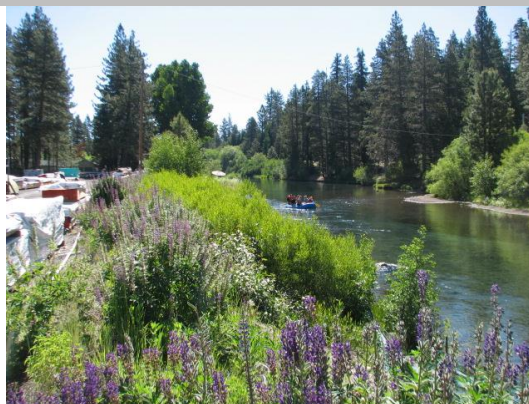
Photo 2 of 4 : CH_2014_NA0045_13_31_20140703_00020.jpg

Inspector Comments: Minimal, scattered obstructions or vegetation. The flow is not impeded.

The vegetation on the berm installed in 2011-12 is maturing. Summer 2014

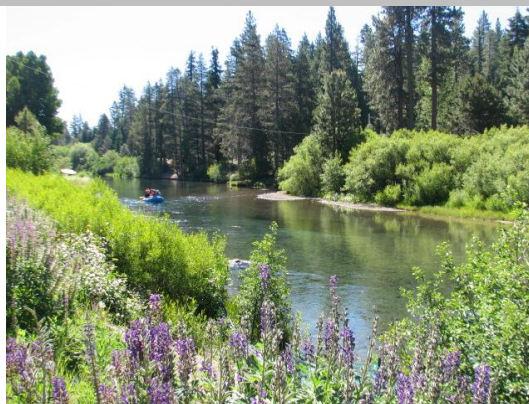
Photo 3 of 4 : CH_2014_NA0045_13_31_20140703_00019.jpg

Looking upstream from Tahoe City Lumber Yard. Summer 2014

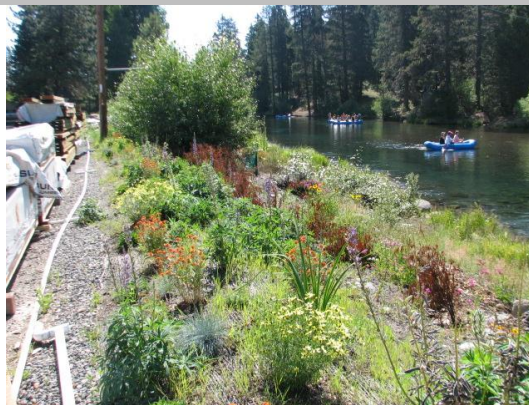
Photo 4 of 4 : CH_2014_NA0045_13_31_20140616_00008.jpg

The vegetation on the berm has grown protecting the embankment. Summer 2013

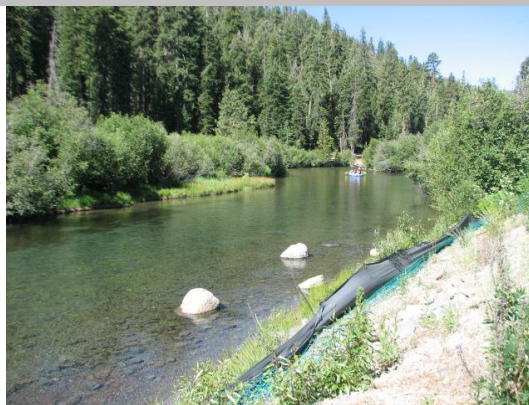
Photo 1 of 2 : CH_2014_NA0045_13_36_20140703_00021.jpg

Inspector Comments: Minimal, scattered obstructions or vegetation. The flow is not impeded.

Looking downstream From Tahoe City Lumber Yard. Summer 2014

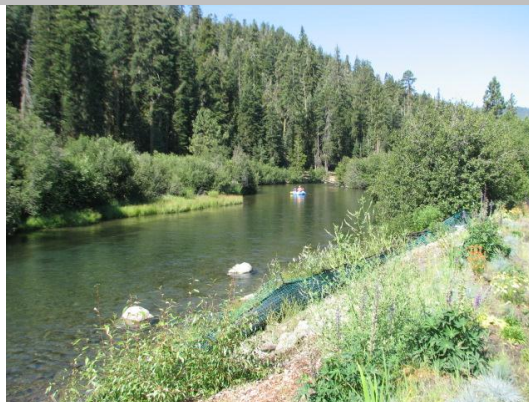
Photo 2 of 2 : CH_2014_NA0045_13_36_20140616_00010.jpg

Looking downstream from Tahoe City Lumber Yard. Summer 2013
